Manhole Inspection Summary

Manhole # S13QQ1008MH

Insp Date: 11/1/06 1:15 PM

Location Address: **2801 OAKLEY AVE**

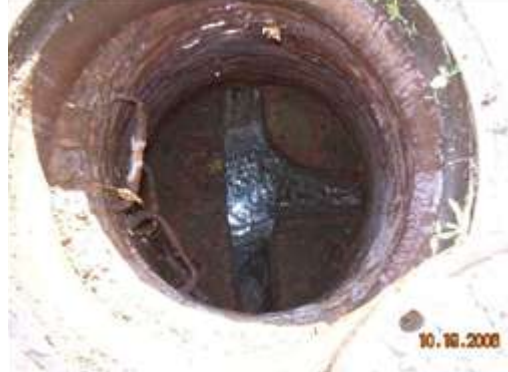
Top View

Frame offset. Corroded steps. Evidence of surcharge - Bench debris.

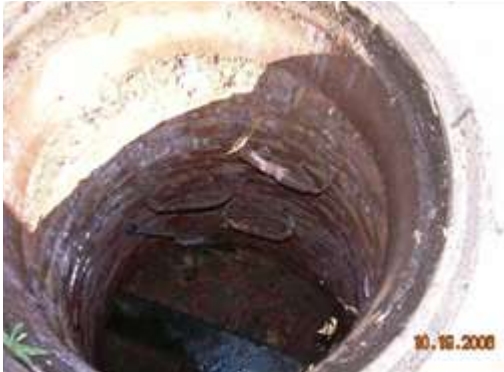
Defect

Condition: ☐ Sound ☐ Cracked ☐ Root Intrusion ☐ Loose Brick ☒ **Deteriorated**

Infiltration: ☐ None ☒ **Joint** ☐ Cracks ☒ **Mortar** ☐ Roots ☐ Wall

Adjustment deterioration and infiltration. Corbel and Barrel infiltration.

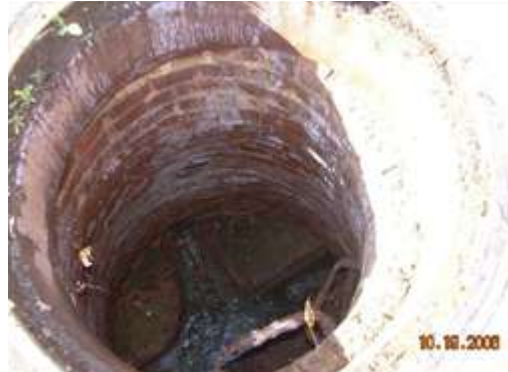
Defect

☒ **Leaks**

Frame leaks. Adjustment, Corbel and Barrel infiltration - other side.

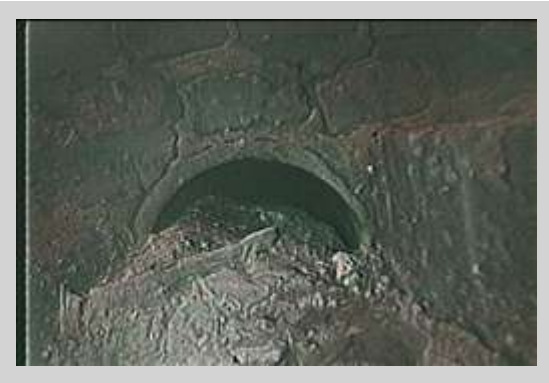
8 in. Circular Gravity Sewer Pipe Out @ 12 O'Clock

Channel debris.

Deposits: ☐ None ☐ Mud ☐ Sludge ☒ **Debris** ☐ Grease

Silt Depth: **4** (in.) Deposits Extent: **Heavy**

Infiltration: **Evidence** Pipe Seal Cond: **Cracked**

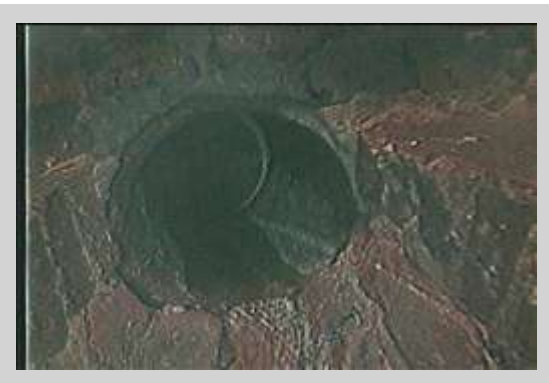
8 in. Circular Gravity Sewer Pipe In @ 3 O'Clock

Channel deterioration.

Infiltration: **Evidence** Pipe Seal Cond: **Unknown**

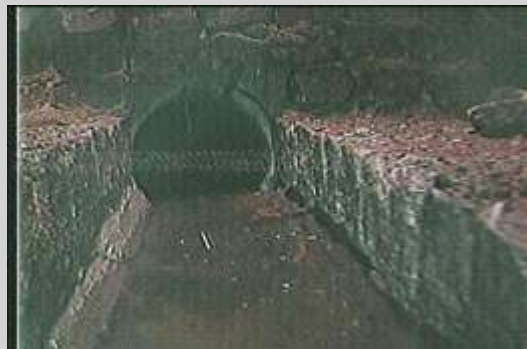
Pipe In @ 6 O'Clock

Barrel deterioration and infiltration. Channel deterioration.

Deposits: ☐ None ☐ Mud ☐ Sludge ☒ **Debris** ☐ Grease

Infiltration: **Evidence**

Pipe Seal Cond: **Roots**
